# Soil Alert 3

## humus podzols

### Podzols with a humus pan

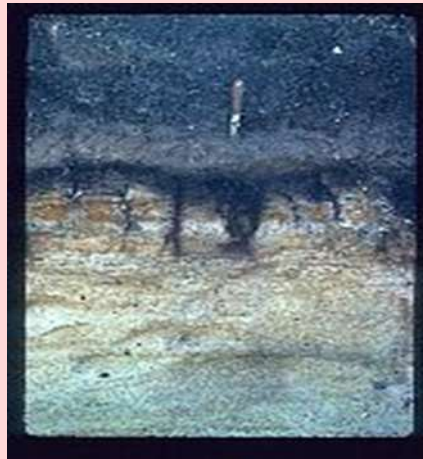
**A heathland podzol. The black central layer is a well-expressed humus pan (Bh horizon)**

In their semi-natural state, these podzols are increasingly the focus of heathland regeneration, or even translocation where they are in the path of infrastructure projects. In undertaking these works it is essential that the humus pan is not mistaken for topsoil, despite its dark colour. This subsoil horizon contains humus, iron and aluminium that have been moved in combination down the soil profile by the podzolization process. It lacks the micro-fauna and fauna of the topsoil and the high levels of aluminium can be phyto-toxic, so it is not a satisfactory growing medium. In excavating these soils, where the topsoil seems to imperceptibly merge with the humus pan, a good rule of thumb is that undisturbed topsoils under semi-natural vegetation are rarely thicker than 20 cm to 25 cm, so proceed with caution below that depth and look carefully for the horizon change. Very often the humus pan is noticeably dense as the humus particles have blocked the soil pores. As always, the message is to dig soil pits before disturbing these soils.
